WATER QUALITY ASSESSMENT AND TMDLS FOR THE FLATHEAD RIVER HEADWATERS PLANNING AREA, MONTANA

PUBLIC REVIEW DRAFT

Prepared by:
U.S. Environmental Protection Agency
Montana Operations Office,
Flathead National Forest,
and Tetra Tech, Inc.

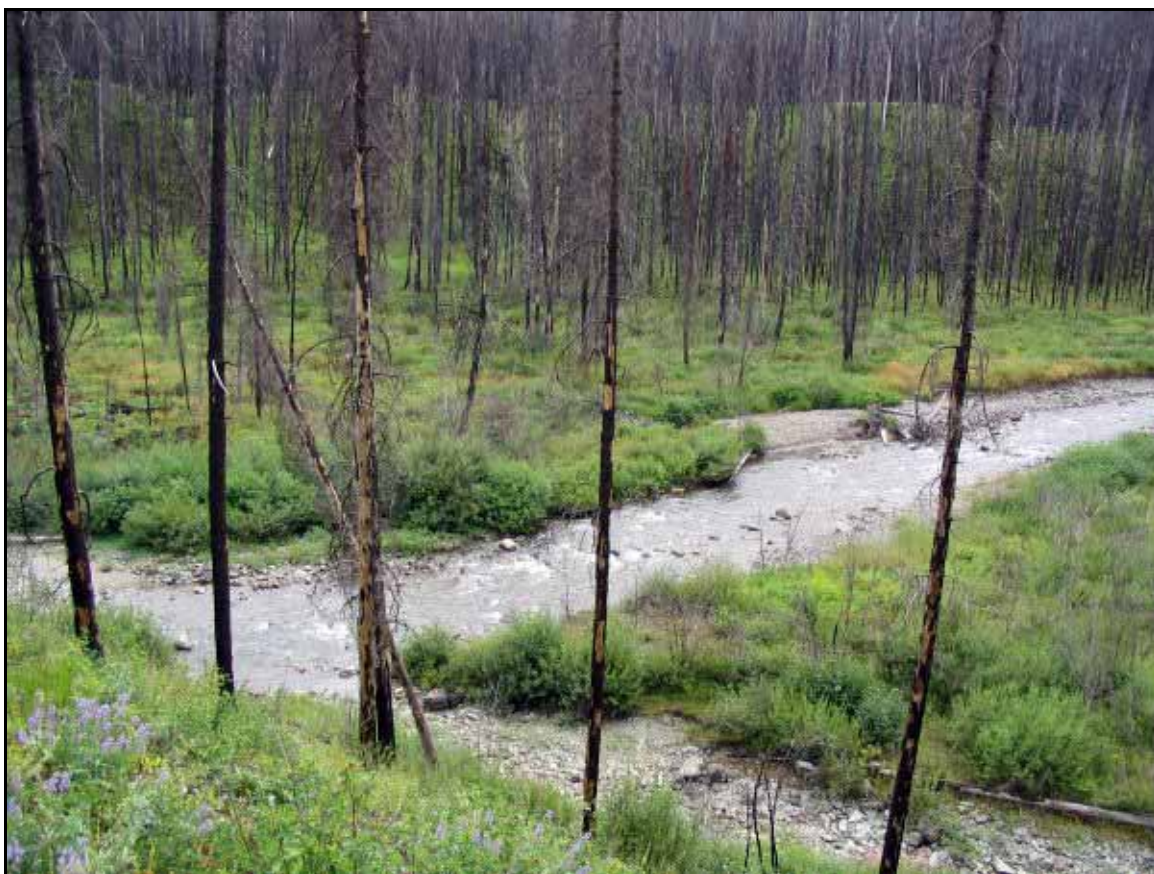
Figure 4-11. Effects of the Moose Fire and vegetative regrowth since 2001 (Note the shrub and herbaceous vegetation that has already resulted in excellent ground cover).

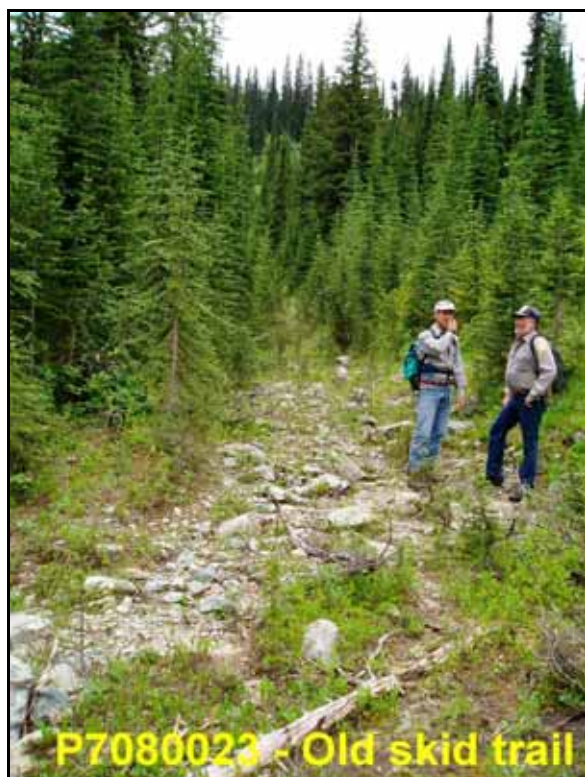
Figure 4-14. Old skid trail with stream formation in the Mathias Creek watershed.
